Research Paper 6

A Survey of the Frost Resistance of Clay Brickwork in the Australian Alps

by Stephen Zsembery and John Macintosh

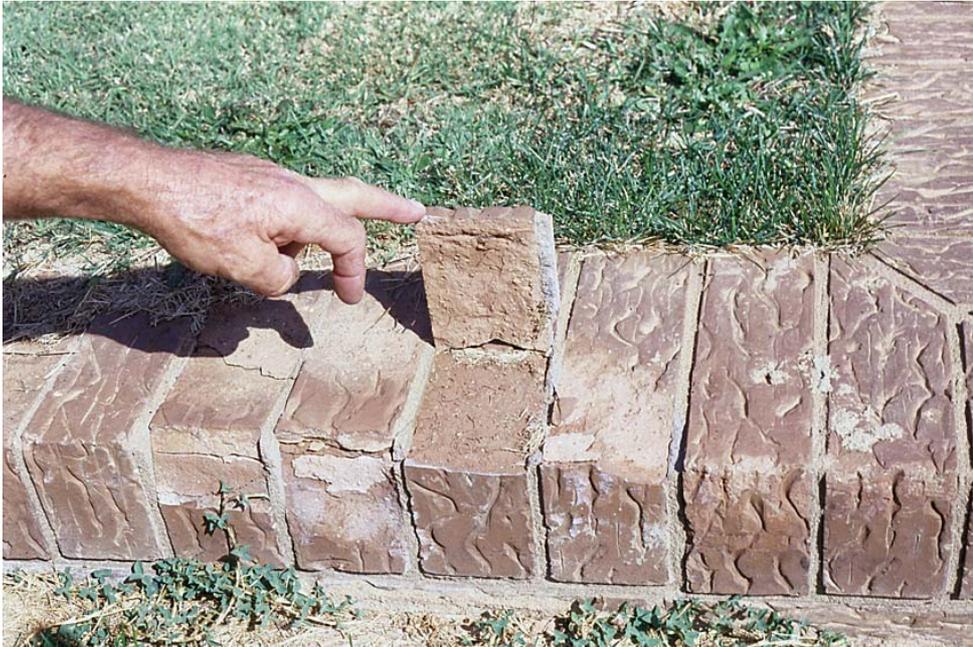
- a) Lawn Cemetery. Extensive frost damage was observed at the Lawn Cemetery, where locally made extruded brown bricks were used as a lawn edge around the memorial wall. See [Figure 2](#). The bricks appeared to have been well made, but not to be highly vitrified.
- b) Common grade bricks used partly below ground level in a rendered retaining wall showed extensive damage due to frost.

During winter the bricks would become completely saturated with water and they would often freeze during the night and thaw during daylight hours. This is an extremely severe test of durability and failure could not be regarded as unexpected. Bricks identical to those used as the lawn edging suffered no damage when used as a wall at the main entrance.

Figure 2. Failure of lightly vitrified bricks in contact with the ground

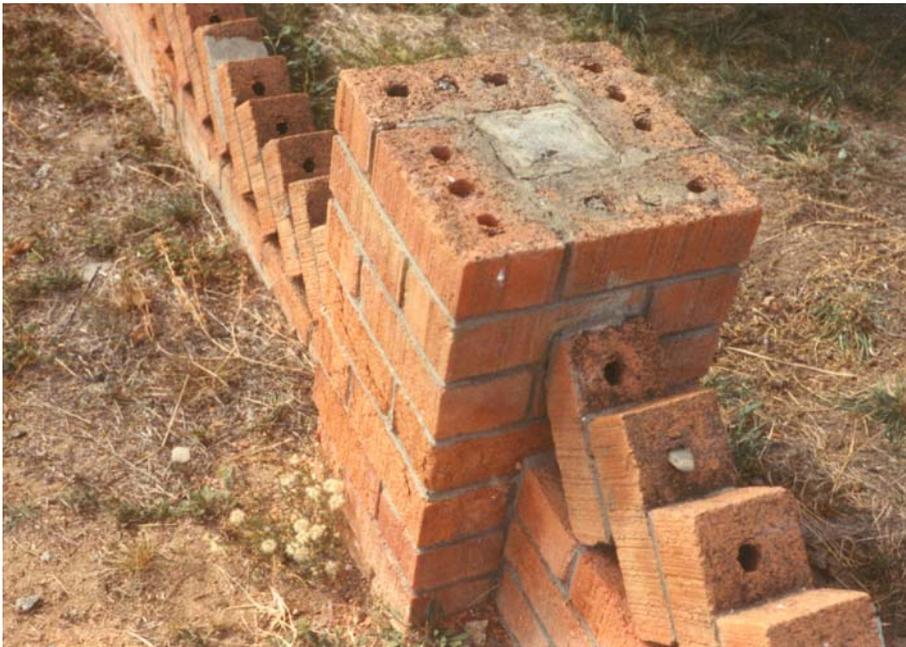
Light coloured extruded bricks in a poorly designed front fence showed extensive frost damage. See Figure 3.

The same bricks used in the house showed no damage. Once again failure was due to frequent cycles of freezing and thawing of saturated bricks.

Figure 3. Frost failure resulting from poor detailing

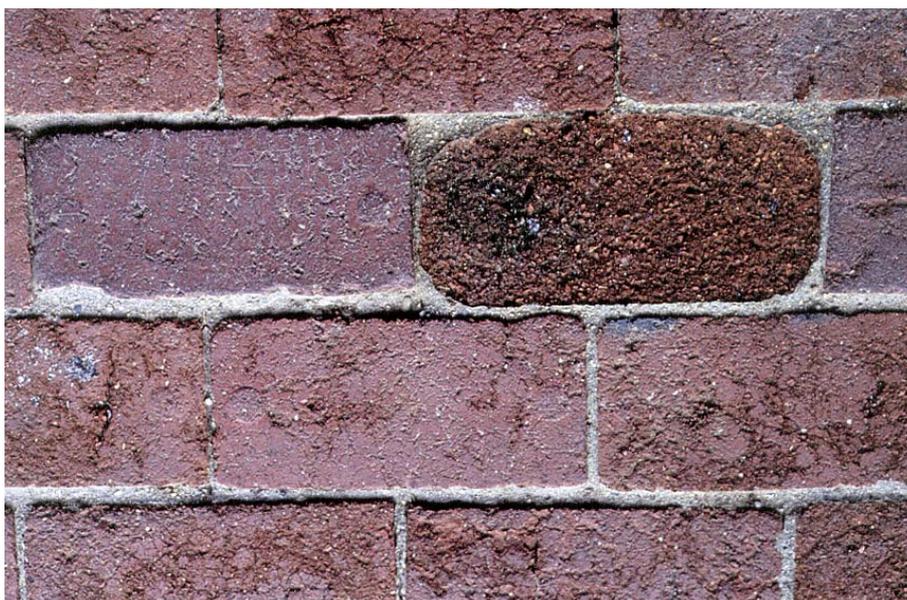
In this case the conditions of exposure were severe; i.e. saturated and with cycles of freezing and thawing. Considering the age of the paving, its condition must be considered acceptable.

Figure 4. Failure of the lighter-fired end of the range of well-made stiff-plastic pressed bricks

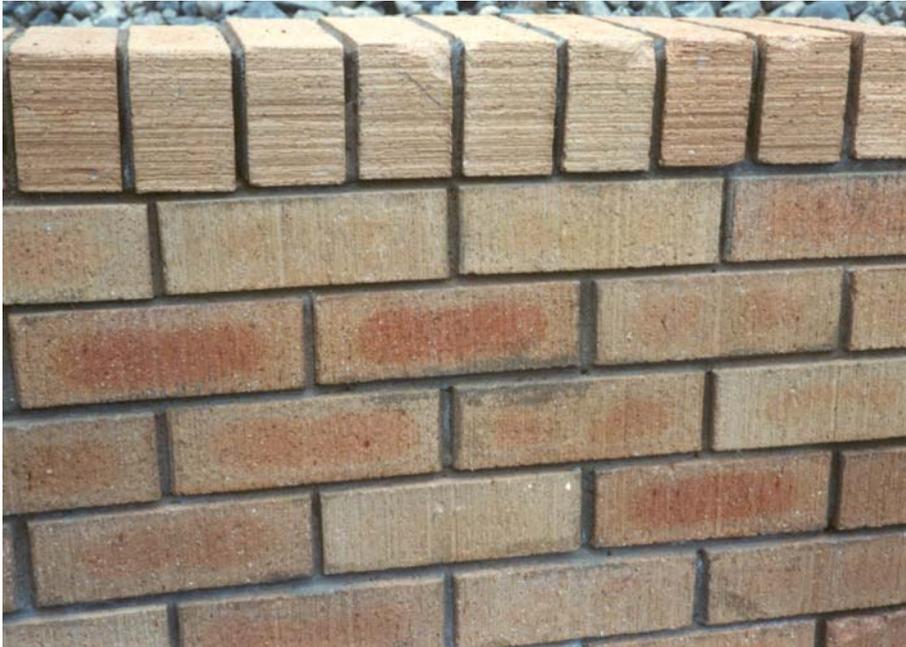
These panels were built three years ago to a design similar to that given in British Standard BS 3921:1974 (see [Appendix A](#)) except that they were five courses lower and a half brick longer. No damp-proof courses were provided at the locations required by this standard. These deviations did not favourably influence the end result as the lack of a DPC should increase the severity of the exposure. The lack of height may be criticised, but the fact that some bricks in one panel deteriorated indicates that the exposure was severe enough to cause failure. See [Figure 5](#).

Figure 5. Exposure panels at Falls Creek after three winters

An interesting feature of these bricks is that those with a relatively weak compressive strength survived the exposure, whilst the strongest (Cream Velour) did not. [Table 2](#) highlights the difficulty of specifying bricks for frost areas from the results of indirect tests. For example, the initial rate of absorption (IRA) and cold water absorption (CWA) values of the Cream Velour and the Grey bricks are similar, the boiling water absorption (BWA) value of the Cream Velours is higher, but, from the high BWA value of the 'Saw Dust' bricks, one could mistakenly conclude that the cream bricks should perform as well as the rest of the panels.

The 'Saw Dust' brick with its (presumably) large pore diameters allows the free drainage of water from those pores before it freezes, whilst the pore structure of the Cream Velour must be such that a greater amount of water is retained.

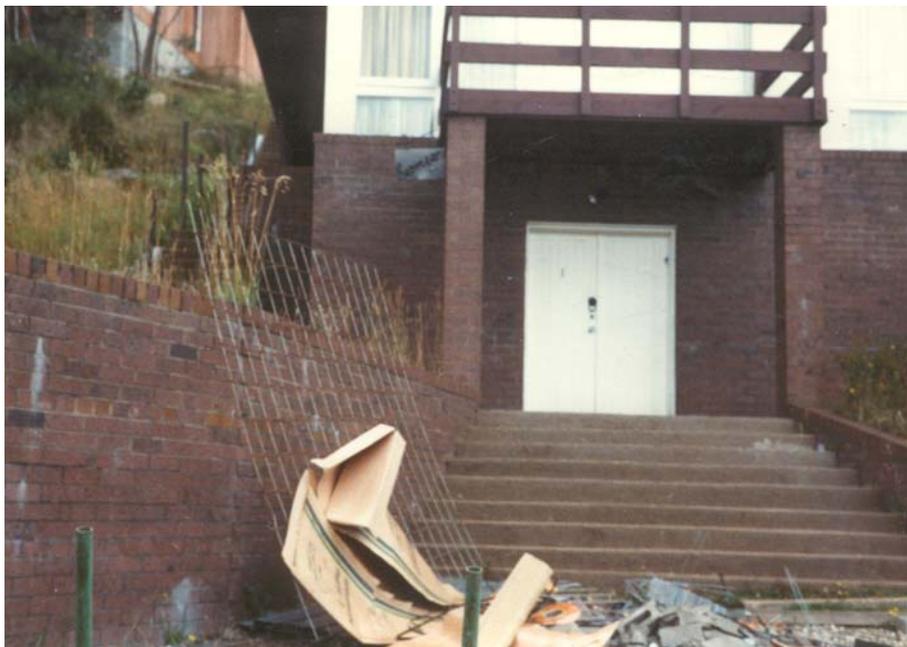
Besides the exposure panels, two buildings were examined. In each case the structures consisted of bricks up to first floor and timber above. One building was built several years ago with reddish-brown extruded bricks containing three extrusion holes. They showed no signs of damage, even under the most severe exposure conditions when used in a substantial earth retaining wall leading-up to the entrance of this building. See [Figure 6](#).

Figure 6. Extruded brown bricks surviving severe exposure (approximately 10 years)

Similar bricks made by the same manufacturer are characterised by IRA values of 0.1 to 0.2 kg/m², cold water absorption of 4 to 5 percent and compressive strength of 80 to 100 MPa.

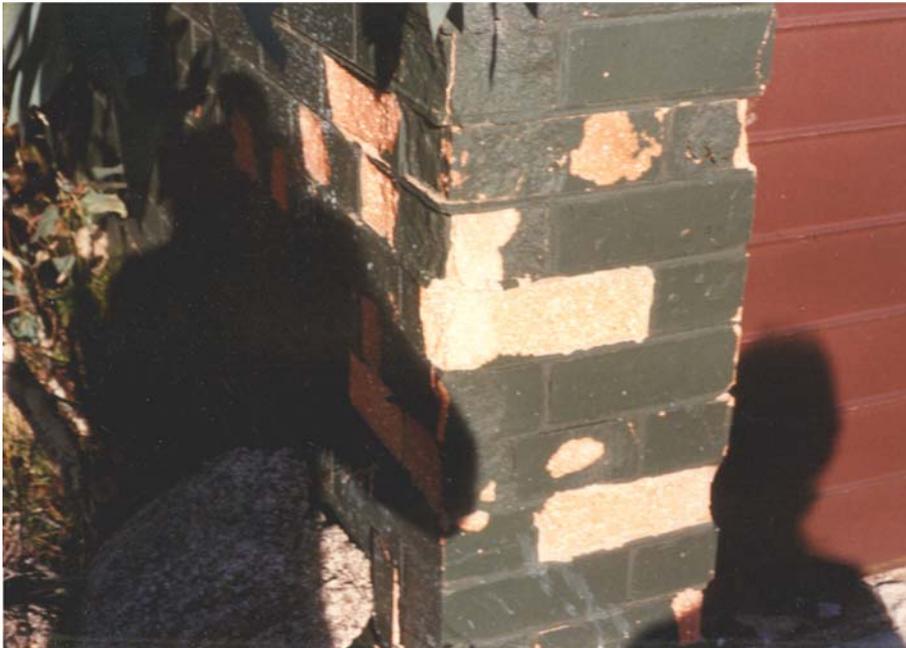
The workshop was built with extruded pink coloured bricks (now painted). Extensive damage was observed. See Figure 7. Whilst these bricks might not be underfired, their body showed very low vitrification.

Figure 7. Failure of (painted) light-coloured extruded bricks

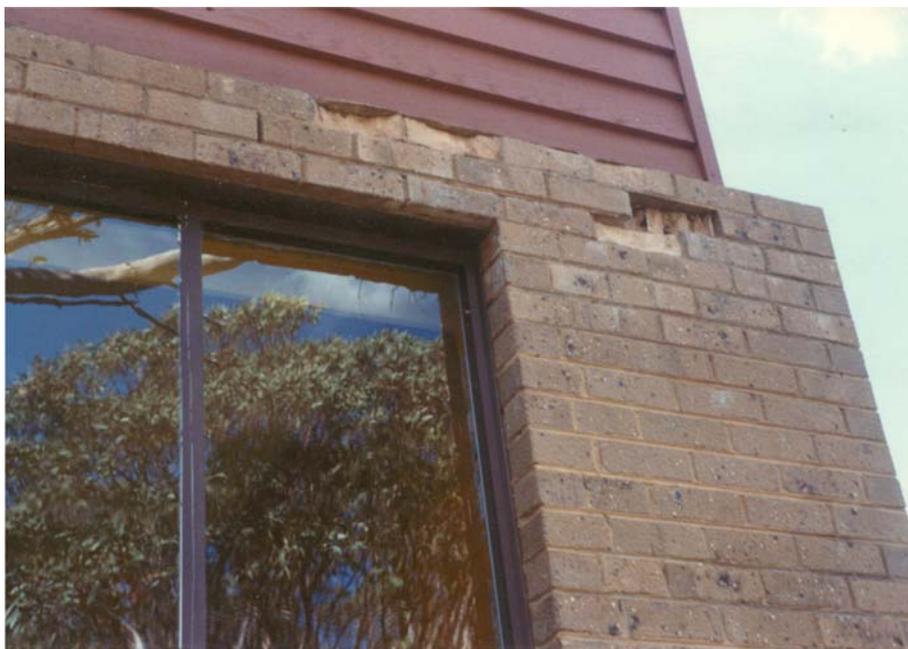
Two buildings were observed with damaged bricks near the exposed top of the walls. In each case the brickwork was protected from the entry of water by only a thin mortar weathering. Obviously such a practice is entirely unsatisfactory. See Figure 8.

Figure 8. Failure of otherwise durable bricks as a result of bad detail

3. **Parapets, chimney tops, retaining and courtyard walls.** Clay brickwork is vulnerable to frost damage in these locations if water can penetrate the structure from the top. The use of cappings of copper, zinc, aluminium or galvanised steel is recommended. Failing this, specially selected bricks should be used and a damp-proof course should be built in near the top of the wall. A practice often observed in this survey (which had invariably resulted in failure) was that of providing a mortar weathering to brick copings. In harsh conditions this method of protecting brickwork is useless.

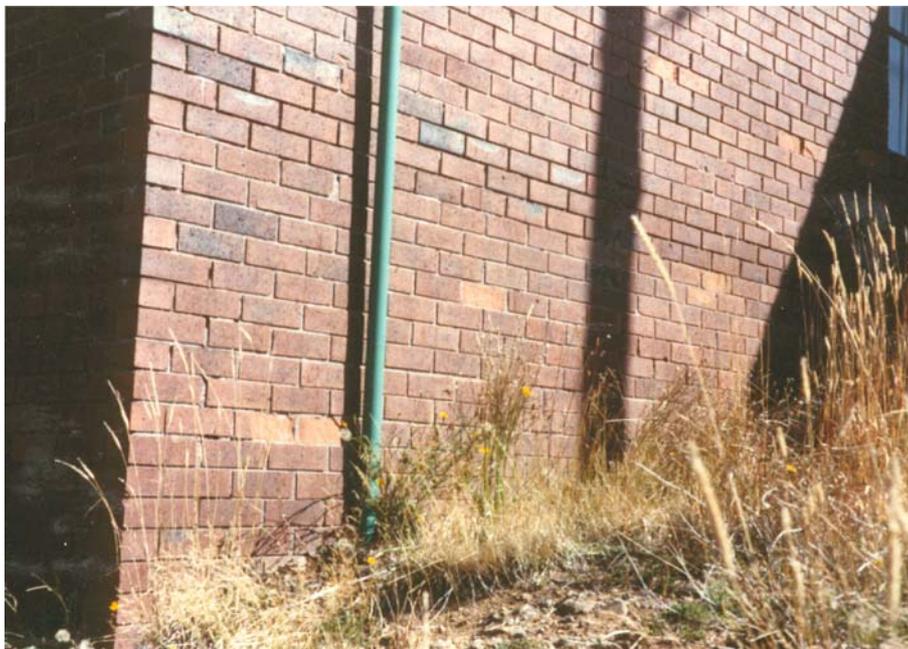
One failure was observed in extruded bricks that would have been sold as first quality on the basis of their appearance. However, after examination of the failed bricks it was clear that these bricks were underfired in a sense that they did not achieve the same degree of fusion during firing as the darker shades of the same consignment which did not fail. See [Figure 9](#).

Figure 9. Low-end of the firing range of these bricks is not frost resistant
