A COMPARATIVE STUDY OF THE THERMAL PERFORMANCE OF CAVITY AND BRICK VENEER CONSTRUCTION

Abstract

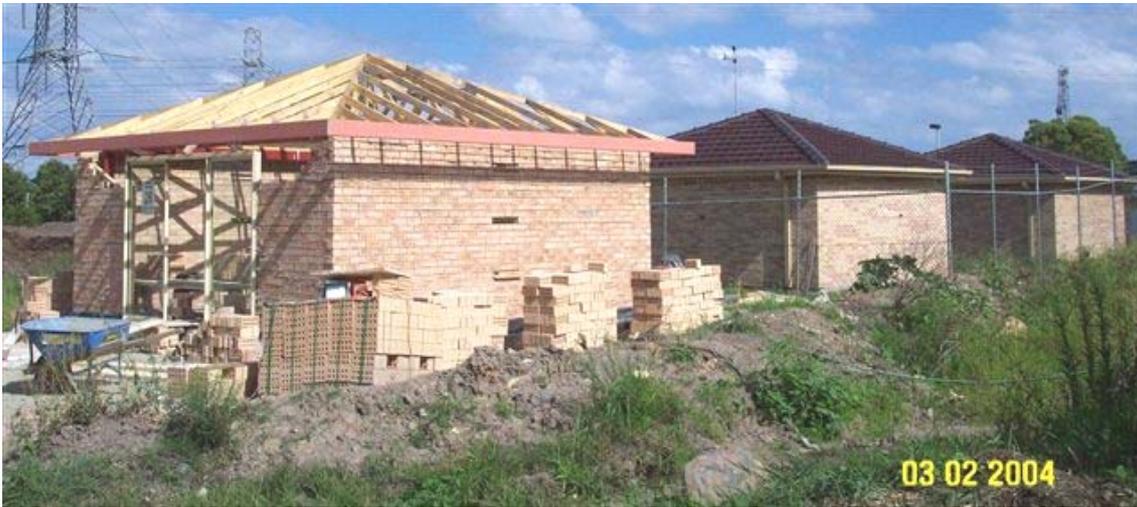
The building modules are built on the Callaghan campus at Newcastle in an open location with uninterrupted solar access. The two modules are shown in the background of Figure 1. The module containing the window (under construction) is shown in the foreground and will not be discussed further in this report. The modules are comparable in size to other buildings used in similar studies (Burch, 1982). The modules have a square floor plan of 6m x 6m and are spaced 7m apart from each other to avoid shading and minimise wind obstruction. With the exception of the walls, the buildings are of identical construction, being built on a concrete slab and aligned in a manner so that the north wall of the buildings is perpendicular to astronomical north. Timber trusses are used to support the roof, consisting of clay tiles placed over a layer of foil sarking. The timber trusses are in turn supported by a steel frame to provide the flexibility of removing/replacing walls at a future stage. The buildings have a ceiling height of 2450mm. The ceiling consists of 10mm thick plasterboard with glasswool insulation bats (thermal resistance or R-value=3.5 m².K.W⁻¹) placed between the rafters. The R=3.5 insulation has been used in the ceiling to minimise the "through-ceiling" heat flow. Entry to the building is via a standard solid timber door located on the southern face of the building. Again, to minimise the flow of heat through the door, a

Figure 1. The Three Building Modules for Thermal Testing.

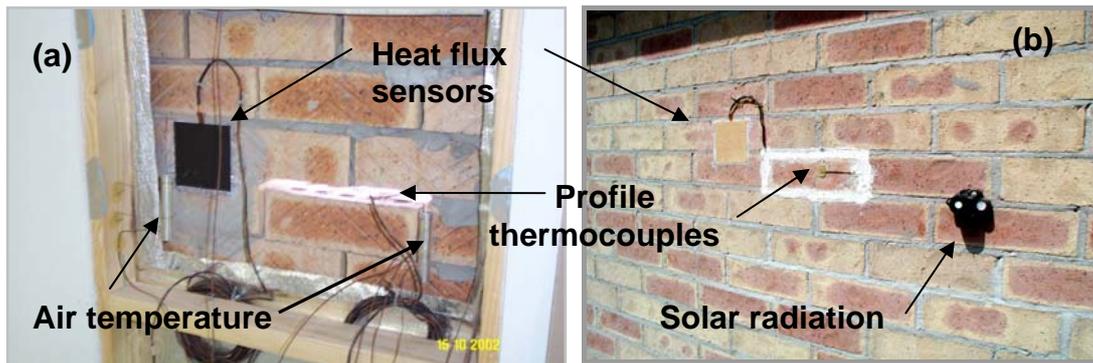
Heat fluxes are measured using 100mmx100mm sensors with typical sensitivities in the order of $25\mu\text{V}/\text{W}/\text{m}^2$. The heat flux sensors were placed on the wall in such a manner that the proportion of masonry unit/mortar ratio being measured was representative of that in the masonry wall. An attempt was made to match the absorbance and emissivity of the heat flux sensors to that of the masonry units by painting the exterior sensors a similar colour to that of the bricks. The interior sensors were painted white, to match the walls, whilst the sensors located in the cavity were painted black to allow radiation heat transfer. Figure 2 shows the typical sensor layout used in the brick veneer wall.

Figure 2. Wall sensors used in the Brick Veneer Wall, (a) internal and (b) external.

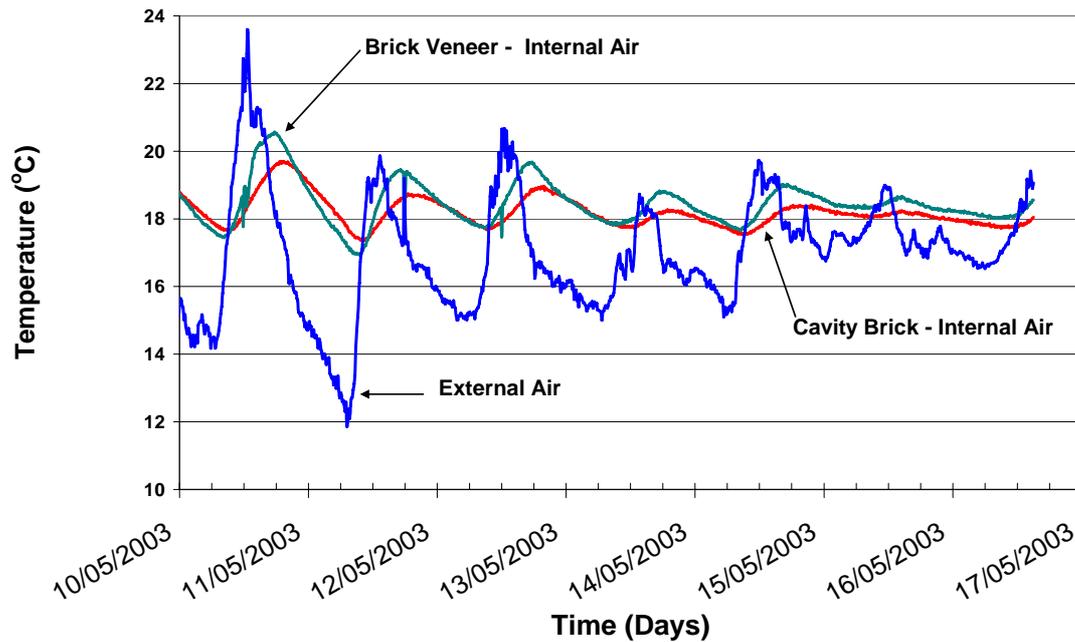
Figure 3 shows the external and internal air temperature for both buildings during the third week of May 2003. The mean external air temperature for this week was 17.5°C and the air temperatures within the cavity brick and brick veneer buildings were 18.5°C and 19.0°C respectively. As expected, the day-night temperature swing in the buildings was much less than that shown by the external air. At the beginning of the week, the swing in the brick veneer building was in the order of 3.5°C and for the cavity brick about 2.5°C whilst the external air swing was in the order of $10\text{-}12^{\circ}\text{C}$. Also, note the marked reduction in day-night variation and minor decrease in the internal temperatures during the latter part of the week due to the presence of cloud cover. In the absence of strong solar radiation, the temperature of the external wall surfaces followed closely the external air temperature. The temperature of the roofing material cooled down to below ambient during the night, regularly reaching $5\text{-}7^{\circ}\text{C}$ for the time period shown in Figure 3. Under sunny conditions, the maximum roof temperatures were in the range of $50\text{-}52^{\circ}\text{C}$.

Figure 3. External and Internal Air Temperatures for the Cavity brick and Brick Veneer Modules, May 2003.

During February 2004 Newcastle experienced heat wave conditions with a maximum air temperature of 43°C being recorded. Figure 6 is similar to Figure 3 and shows the external and internal air temperature for both buildings during the third week of February 2004. The mean external air temperature for this week was 24.7°C and the mean air temperatures within the cavity brick and brick veneer buildings were 26.2°C and 25.9°C respectively. The maximum external air temperature recorded adjacent to the test buildings was 42.5°C at 2pm. At this time, the internal air temperature in the Cavity Brick module was 28.5°C and 28.7°C in the Brick Veneer building. The maximum internal air temperature for the Cavity Brick occurred at 8:30pm and was 29.7°C. For the Brick Veneer building a maximum of 30.5°C occurred at 6:00pm. The maximum external surface temperature recorded on this day was 72°C on the tiled roofs at 2pm. The hottest external wall temperature was 46°C recorded on the west facing walls at 4:30pm.

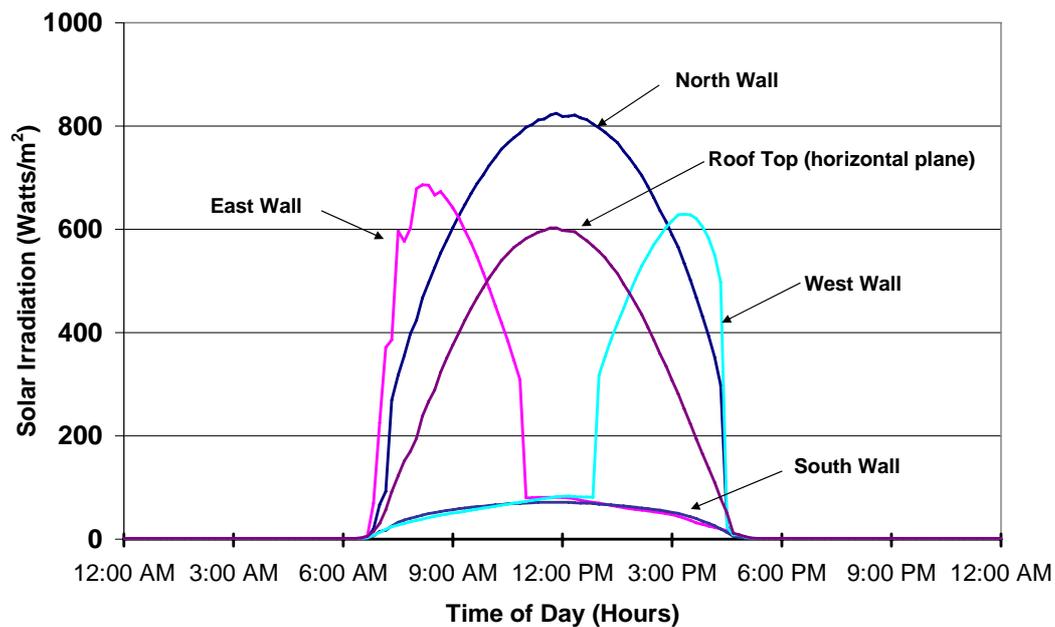
At this time of the year the solar altitude is approaching a minimum and this resulted in the north facing wall receiving a greater quantity of solar radiation than that observed on the horizontal plane, as shown by Figure 4. Note the reduced irradiation levels experienced by the east and west facing walls and, the diffuse radiation received by the south (shaded) wall which is in the order of $80\text{ W}/\text{m}^2$.

Figure 4. Incident solar irradiation on the exterior building surfaces for 22nd May 2003

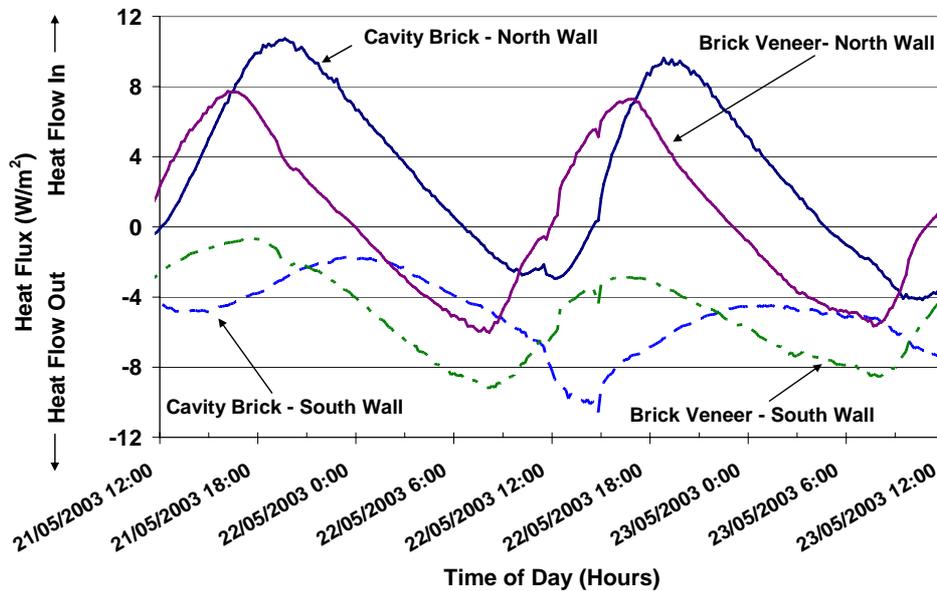
The effects of solar radiation can be observed by the rise in wall temperatures and the changes in the heat flux entering via the walls. During May, the exterior of the North facing walls regularly reached 35°C during sunny days. For clarity, only the data recorded by the North and South heat flux sensors, mounted on the internal walls, is shown in Figure 5. Note that the polarity of the sensors has been arranged with heat entering the interior space being recorded as positive whilst heat 'flowing out' being seen as negative. The flux entering through the North wall of the Cavity Brick building is greater than that observed for the Brick Veneer. Also, the heat flow balance, either in or out, favours a greater proportion of heat 'flowing in' for the Cavity Brick building. The

time when the maximum in-flowing flux occurs is also different, with the Brick Veneer Building showing a shorter lag time, (4.5 hours) compared to the Cavity Brick module of about 8 hours. The heat flux entering via the North wall also influences the South wall behaviour, with maximum and minimums being observed. In these cases, heat is continuously flowing out via the South walls since the values are always negative. Flux variations can also be observed in the East and West walls but are not as pronounced.

Figure 5. Heat Flux Measurements on the Interior North and South walls of the Cavity and Brick Veneer Buildings for 22nd May 2003.

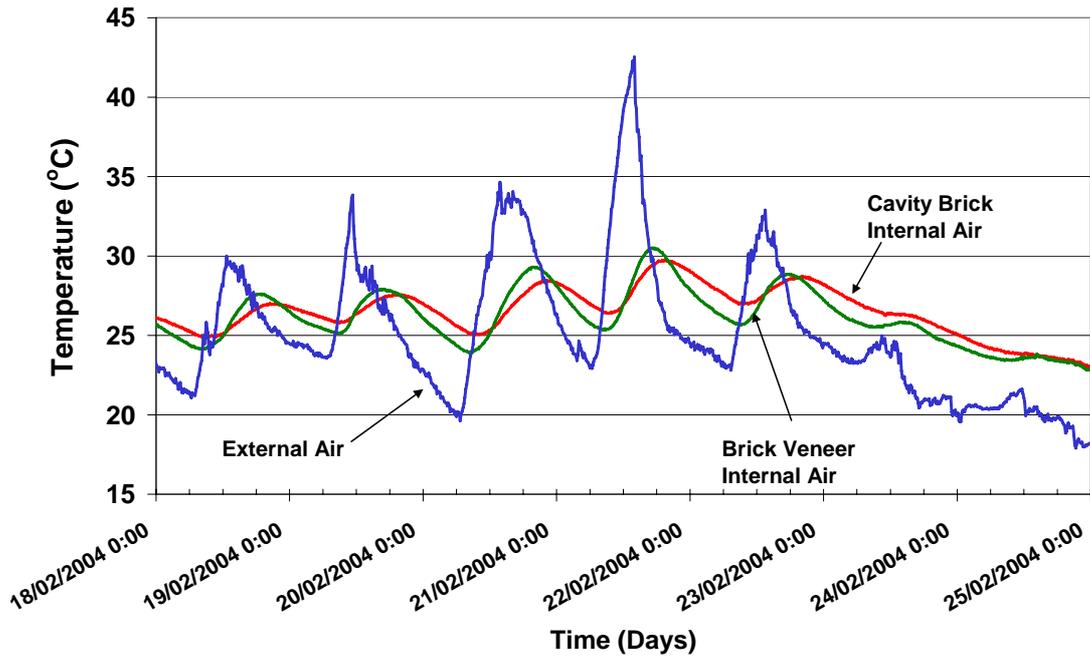
The external air day-night temperature swing was much greater at this time of the year than that in May, being in the order of 15-20°C. However, the temperature swing within the buildings shows only a minor increase, being 3-3.5°C for the Cavity Brick and about 5°C for the Brick Veneer building as indicated in Figure 6. Note the cooler weather conditions at the end of the week and the steady decline in internal temperatures of the buildings. Both buildings remained warmer than the external air conditions for several days.

Figure 6. External in Internal Air Temperatures for the Cavity brick and Brick Veneer Modules, February 2004.

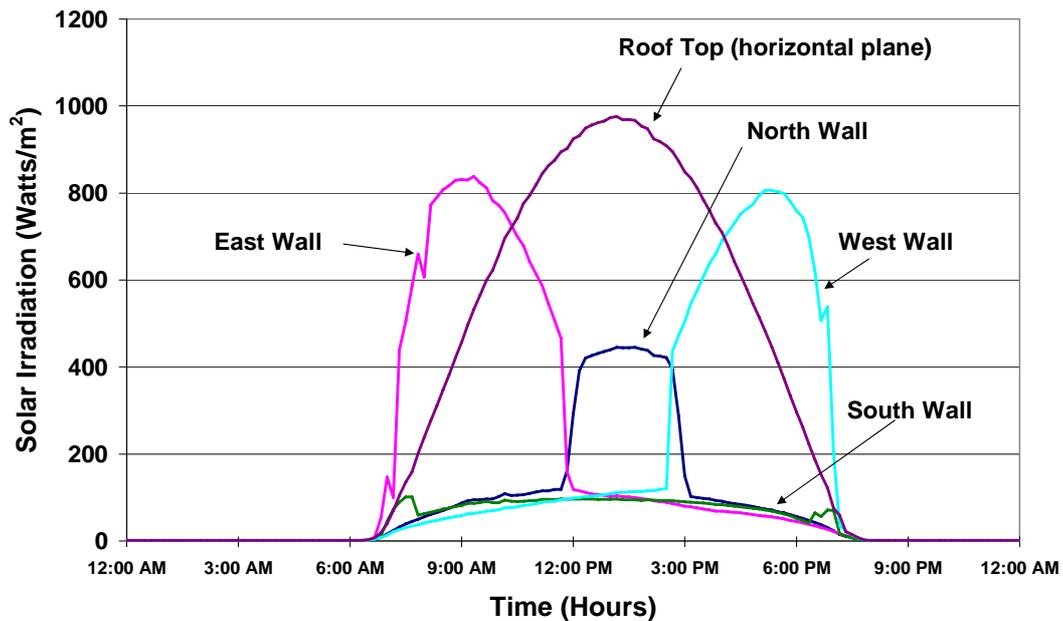
The incident solar radiation on the exterior surfaces of the buildings has also changed, with the East and West orientated walls receiving higher radiation levels for longer periods of time. The radiation falling on the North wall has decreased significantly ($\approx 450 \text{ W/m}^2$) due to the higher solar altitude and is further attenuated by the eave providing shade on the wall. The level of radiation observed on the horizontal plane has increased, reaching a maximum of just under 1000 W/m^2 . The diffuse radiation being received by the South wall has increased marginally up to a maximum of 100 W/m^2 . These trends are shown below in Figure 7.

Figure 7. Incident solar irradiation on the exterior building surfaces, 20th February 2004.

Comparison of Figures 7 and 8 shows that there is a substantial attenuation of the solar radiation flux, the peak value is in the order of 800W/m², yet only a small proportion of that enters the building. This behaviour is explained more clearly by observing the through-wall flux profile presented in Figure 9. Again, for clarity only the profile through the West wall of the Cavity Brick building is shown. The flux attenuation through the West wall of the Brick Veneer building has very similar characteristics.

The data in Figure 9 shows that the maximum heat flux entering the external brickwork on West wall is about 200W/m² compared to the incident flux of 800 W/m² falling on the wall over the same time period shown in Figure 7. This would indicate that a large portion of the heat is reflected or radiated back to the external environment by the exterior surface of the brick. Figure 9 also shows that significant amounts of the heat stored in the wall is released back to the exterior environment, indicated by the large negative flux regions occurring during the night. Also, note the significant difference

The data also demonstrates the ability of masonry walling systems to attenuate incident solar radiation. For summer conditions, Figures 7-9 show that the peak solar radiation levels falling on the West wall are in the order of 800W/m² with only about 200W/m² being absorbed by the exterior masonry surface. However, the peak flux values entering the buildings are very low, 12-13W/m². The reduction of flux values is a result of the thermal properties of the masonry walls and the cooler night time temperatures allowing much of the stored heat in the masonry wall to be re-radiated to the outside environment. The results also emphasise the need for appropriate roof insulation due to the extreme temperature range experienced by roofing materials (-4 to 70°C). The roof cools down below ambient temperature during the night and receives high levels of solar radiation for prolonged periods of time during summer.

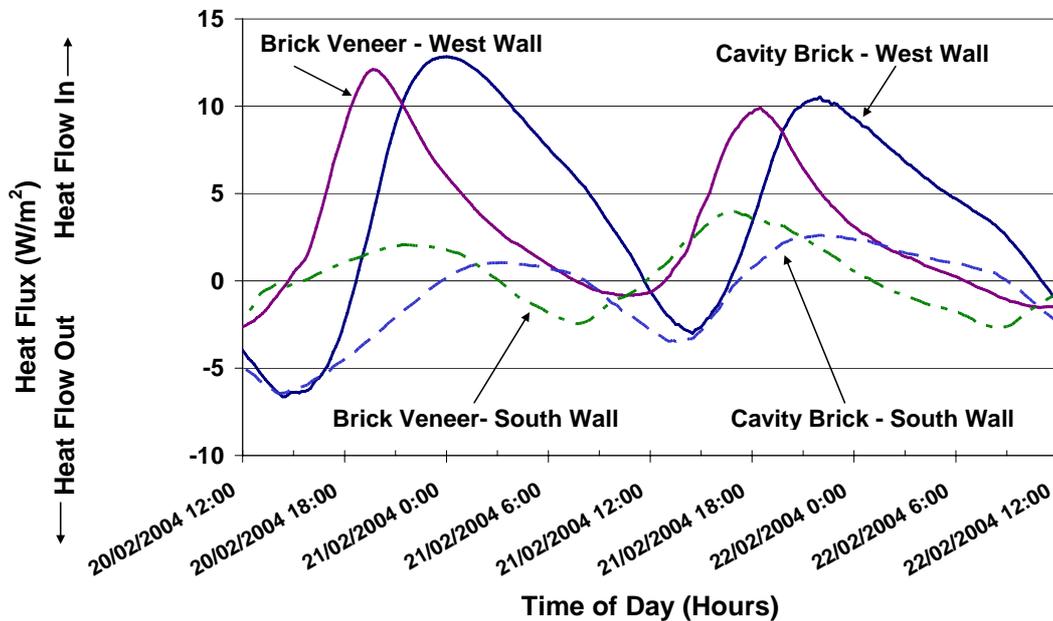
These changes in solar radiation influenced the thermal behaviour of the walls. The exterior surface temperature of the South and North walls followed closely the external air temperature. The East and West walls reached higher temperatures, with the West wall recording the hottest temperatures in the range of 40-52°C in the afternoon. When the walls were out of direct sunlight, in shade or at night, the exterior surface of the walls cooled down to the external air temperature. Examination of the heat flux readings on the interior surfaces shows that heat enters via the East and West walls and leaves via the South wall. Figure 8 shows this behaviour although for clarity only the West and South wall interior flux are shown. The peak flux entering through the West walls is in the order of 12-13W/m² for both buildings (also note that some heat flows out as well). Figure 8 also shows that heat generally flows out via the South wall with maximum and minimums being observed. Again, note the different lag time for the buildings, the peak solar radiation on the West wall was at 5:30pm however, the peak heat flux occurred around 8pm for the Brick Veneer and 10pm for the Cavity Brick building.

Figure 8. Heat Flux Measurements on the Interior West and South walls of the Cavity and Brick Veneer Buildings for 21st February 2004.

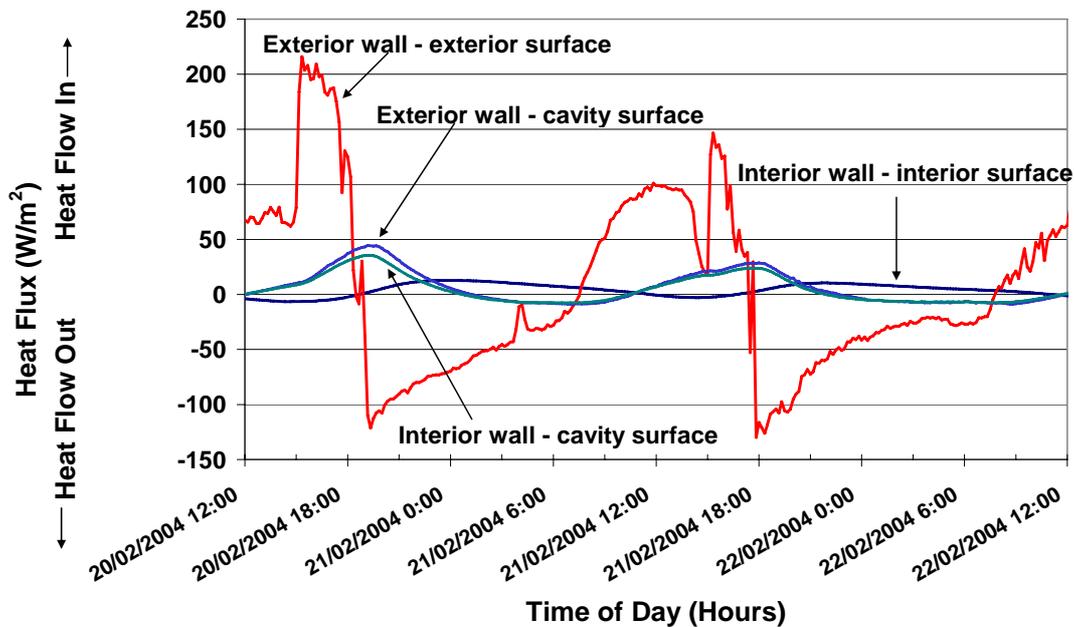
between the observed heat flux on the external and cavity surfaces of the exterior masonry skin. This attenuation reduces the peak heat flux from about 200W/m^2 to 50W/m^2 . This behaviour is again repeated by the interior masonry skin and further attenuates the flux down to peak values of $12\text{-}13\text{W/m}^2$ as shown in Figure 8. The flux reversal occurs through both masonry skins and reduces the net flux entering the building. This reversal is driven by day-night temperature swing with cooler night time temperatures increasing the radiation and convective heat transfer rate from the masonry wall to the outside environment.

Figure 9. Through-Wall Heat Flux Profile of the West walls of the Cavity Brick Building on the 21st February 2004.
